**NOVEMBER 20, 2021  
NORTH BALD HEAD WYND  
STRUCTURE FIRES  
AFTER ACTION ANALYSIS**

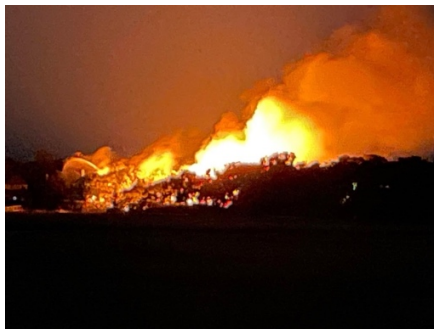
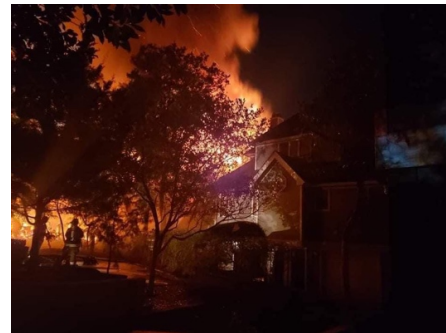
Photos provided by BHI Department of Public Safety

It is clear that this fire went from an incipient stage to fully developed stage that spread to exposures quickly. The fire went undetected in early stages due to the lack of occupants and no fire alarm systems to notify first responders. Weather conditions contributed to fire conflagration.

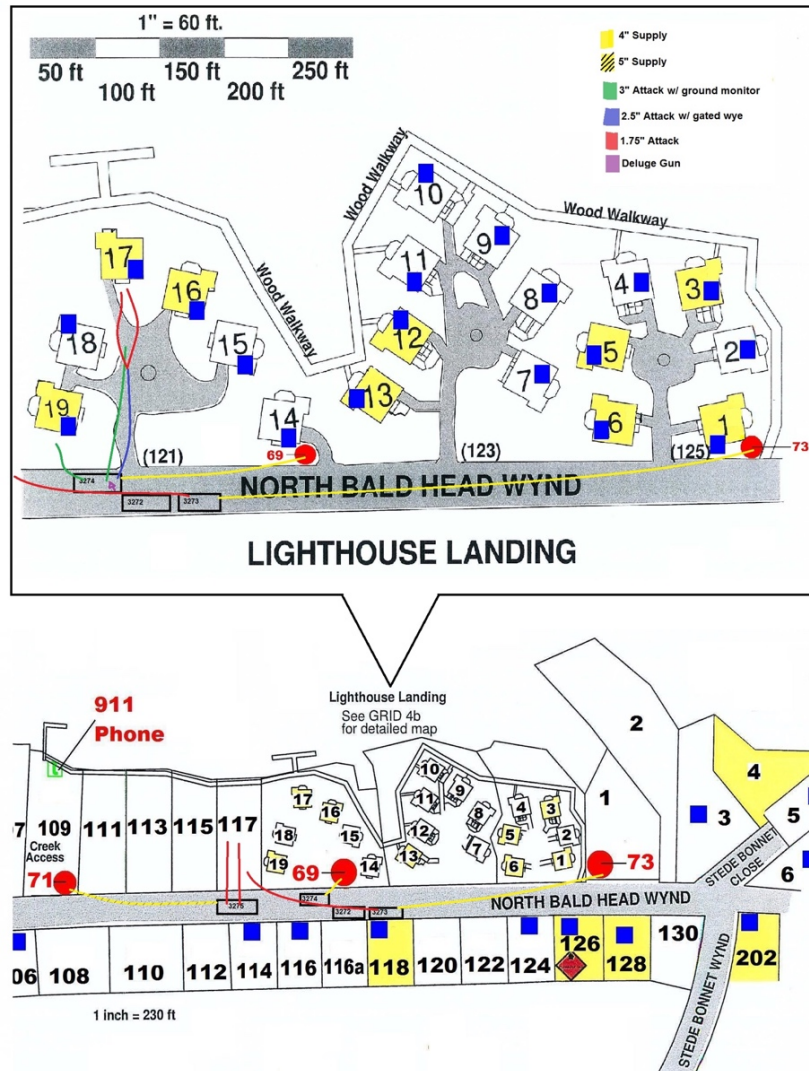
The following diagram was completed by Bald Head Island Department of Public Safety to show involved structures, hydrant locations, apparatus placement, and hose placement.
