CHARLOTTE FIRE DEPARTMENT

# LIBERTY ROW FIRE AFTER ACTION REPORT

INCIDENT # 23-0147427

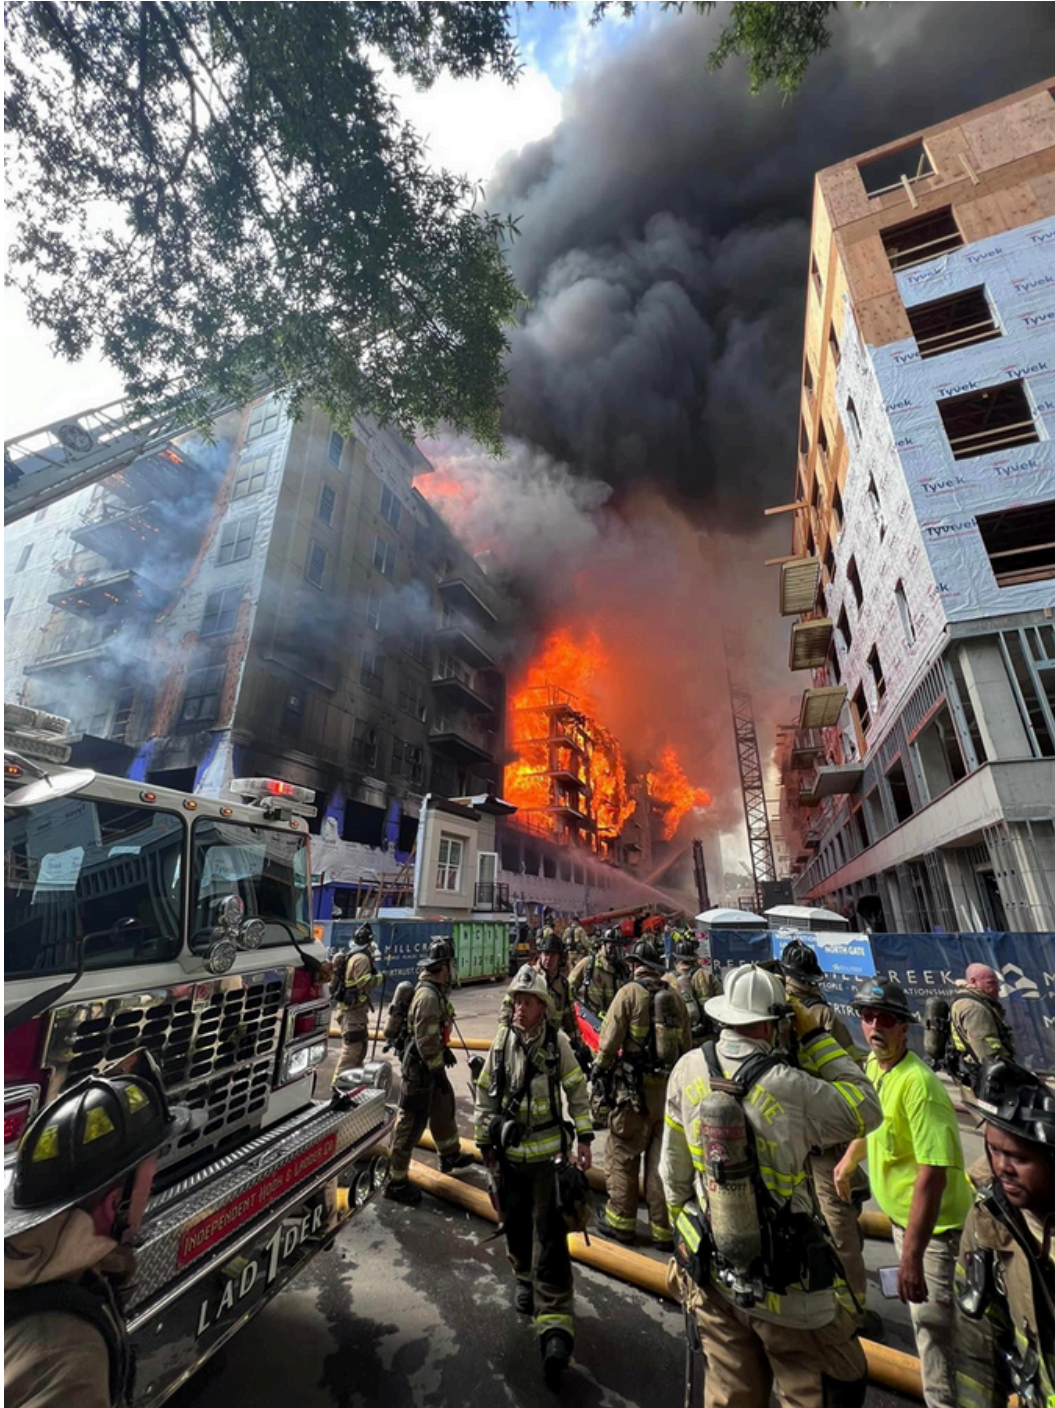
Ladder 1 – positioned on the “Bravo/Charlie” corner between the two buildings under construction.

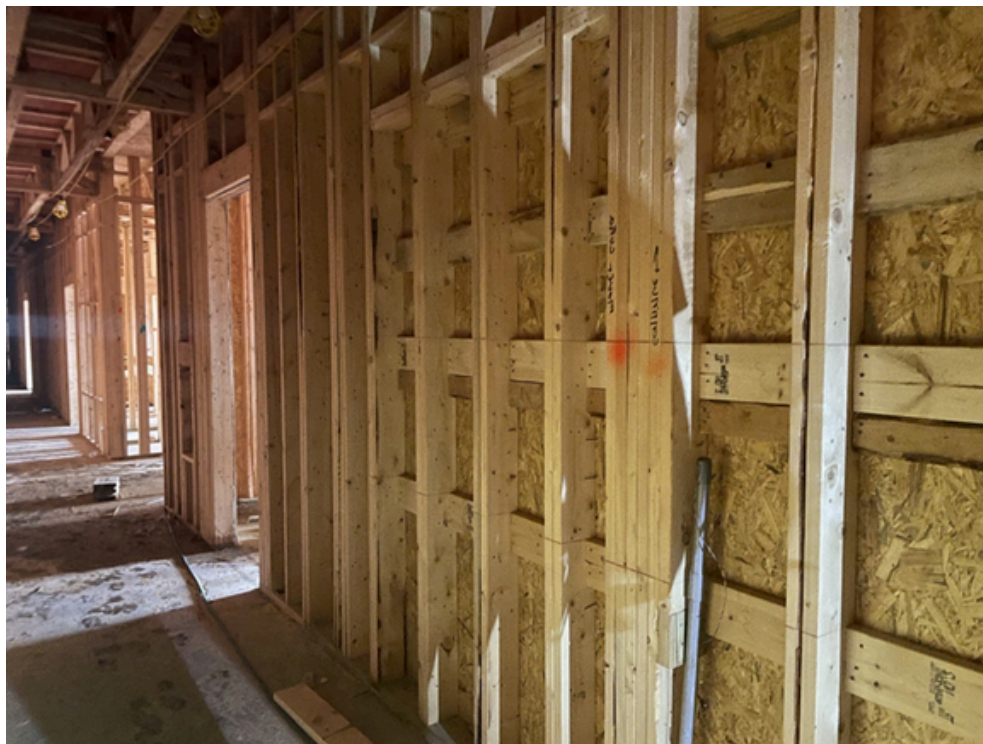
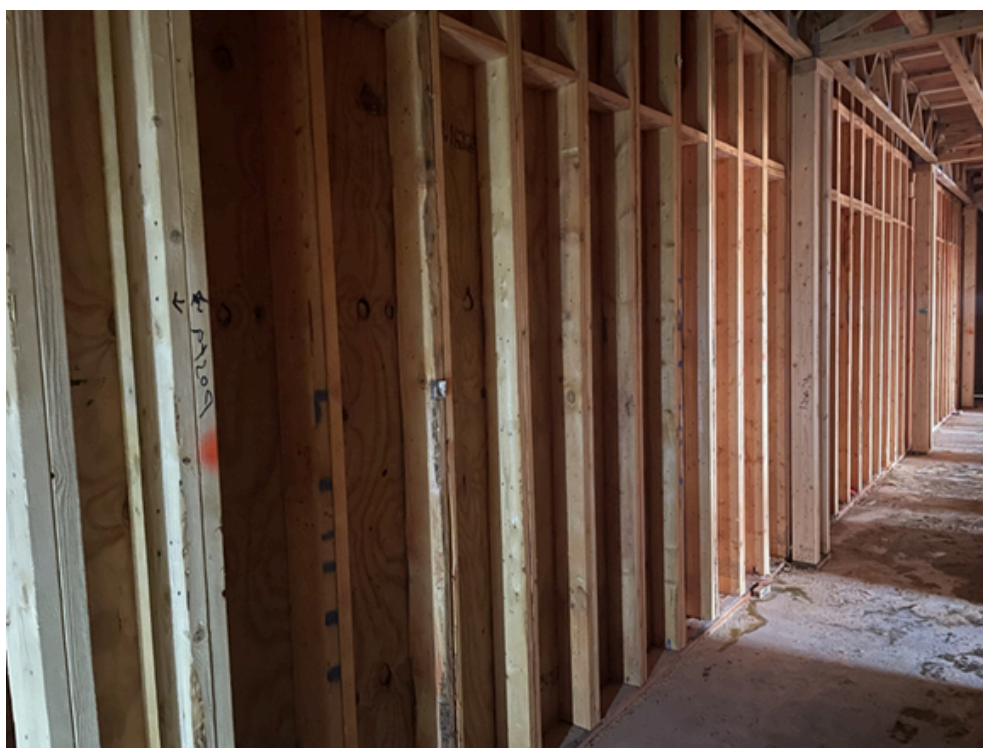
Interior (top picture) and exterior (bottom picture) wall construction

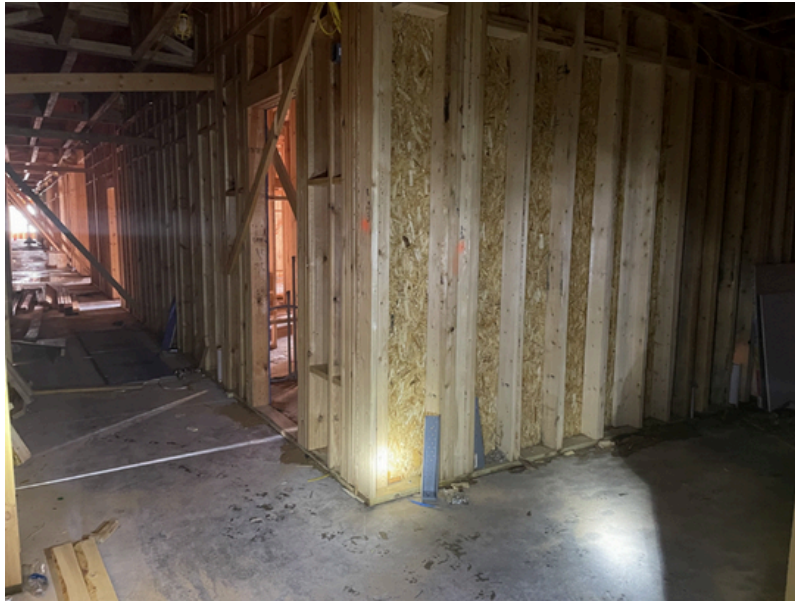
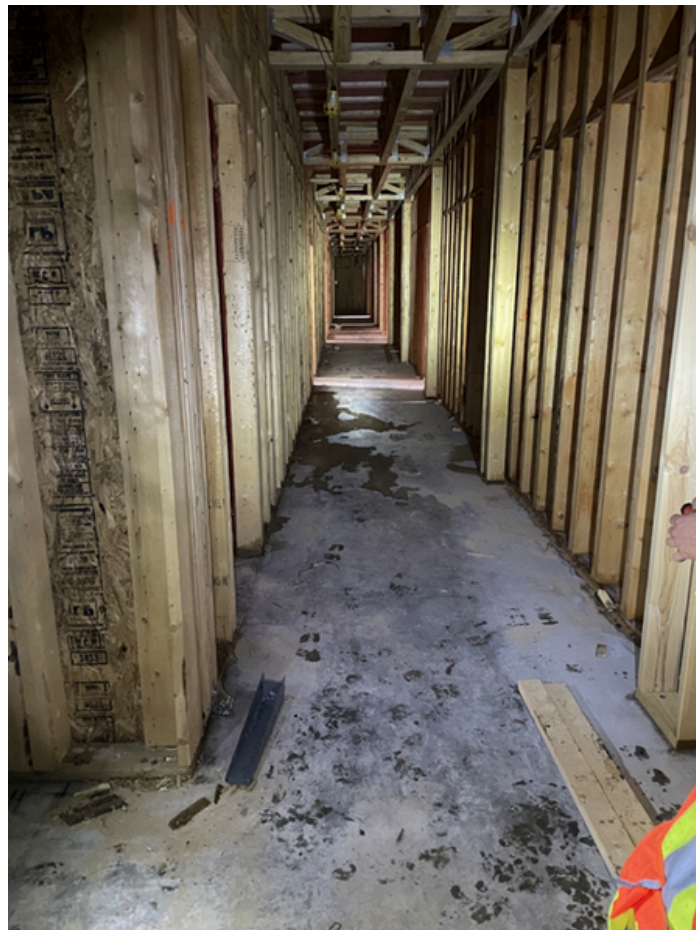
Top picture – Hallway at center corridor, looking towards the “Alpha” side.  
Bottom picture – Hallway looking towards the exit.

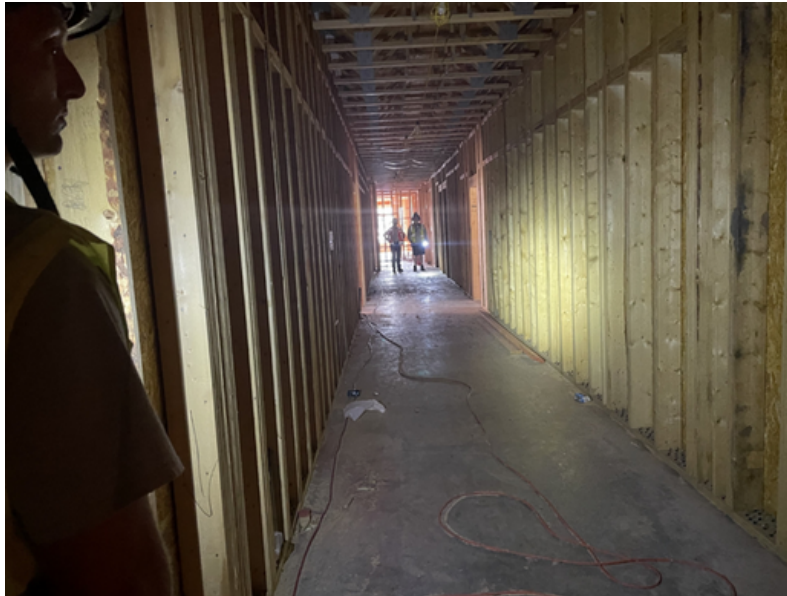
Top picture – Hallway that L01 entered from the stairs. Flashlight indicating stairwell location.

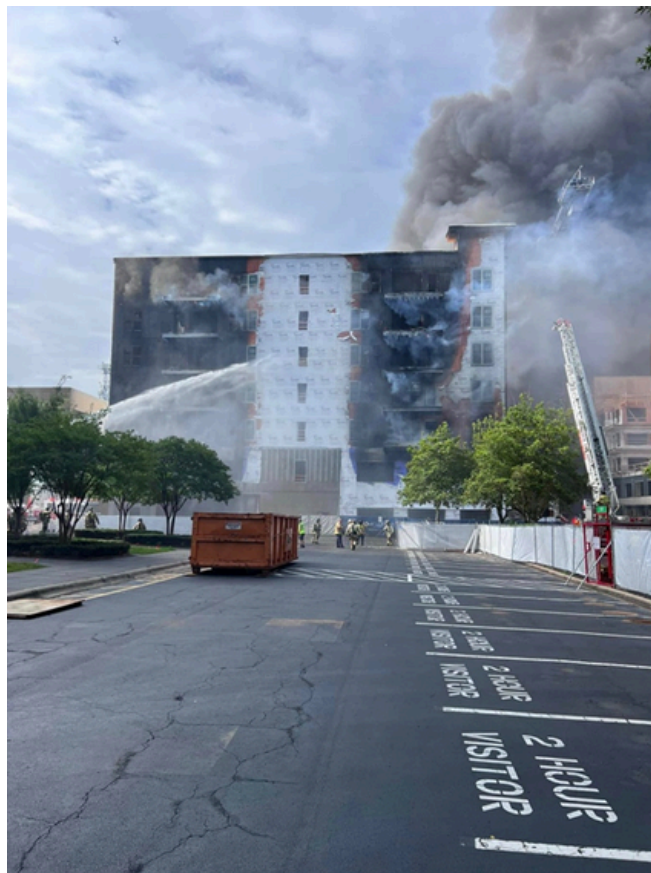
Bottom picture – The apartment that L01 found themselves in while searching for the exit.(Look left, and up, of the aerial stream on the top floor) This is the “Charlie/Delta” side

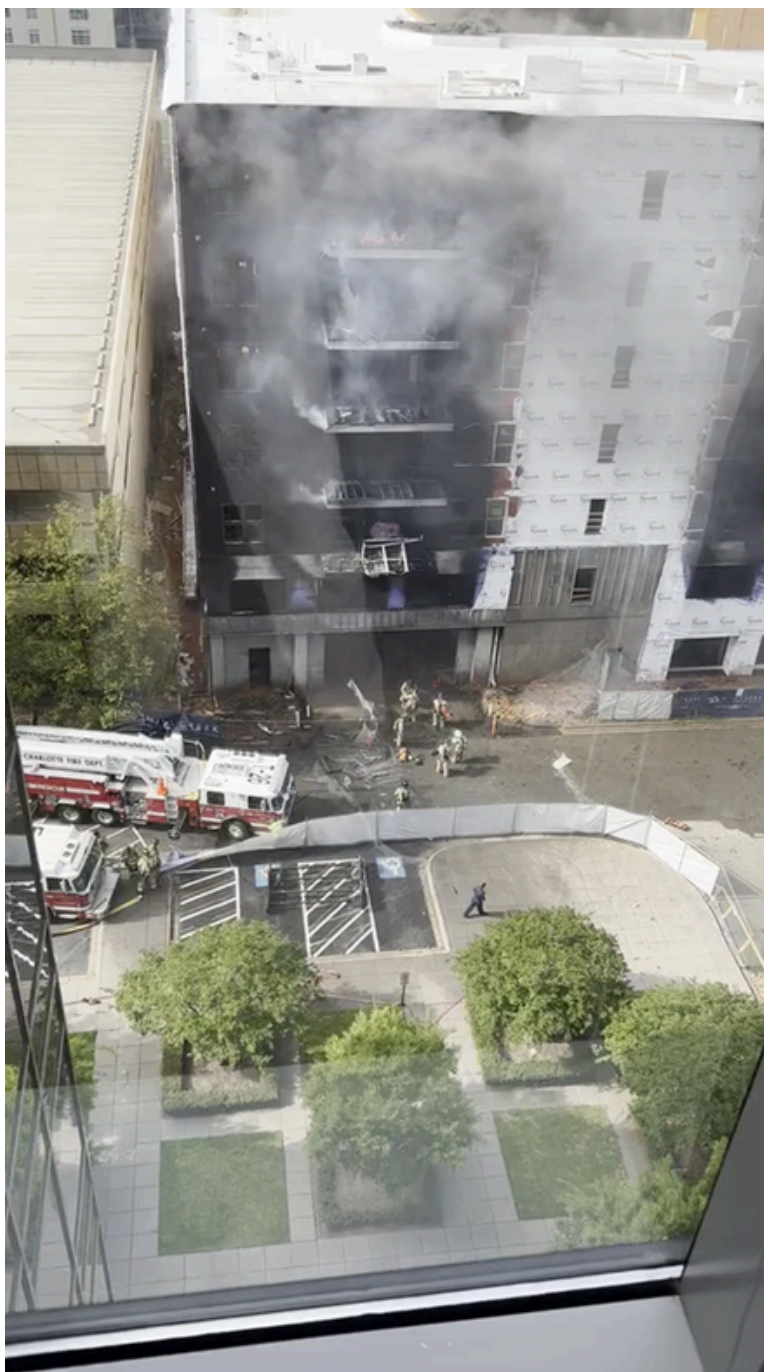
L01 crew attempted to tell the RIC where they were located. They used a landmark of Tower 26, but the message was either covered up or unheard. Running out of options, Captain Watts thought about dropping a tool out to get someone's attention on the ground.

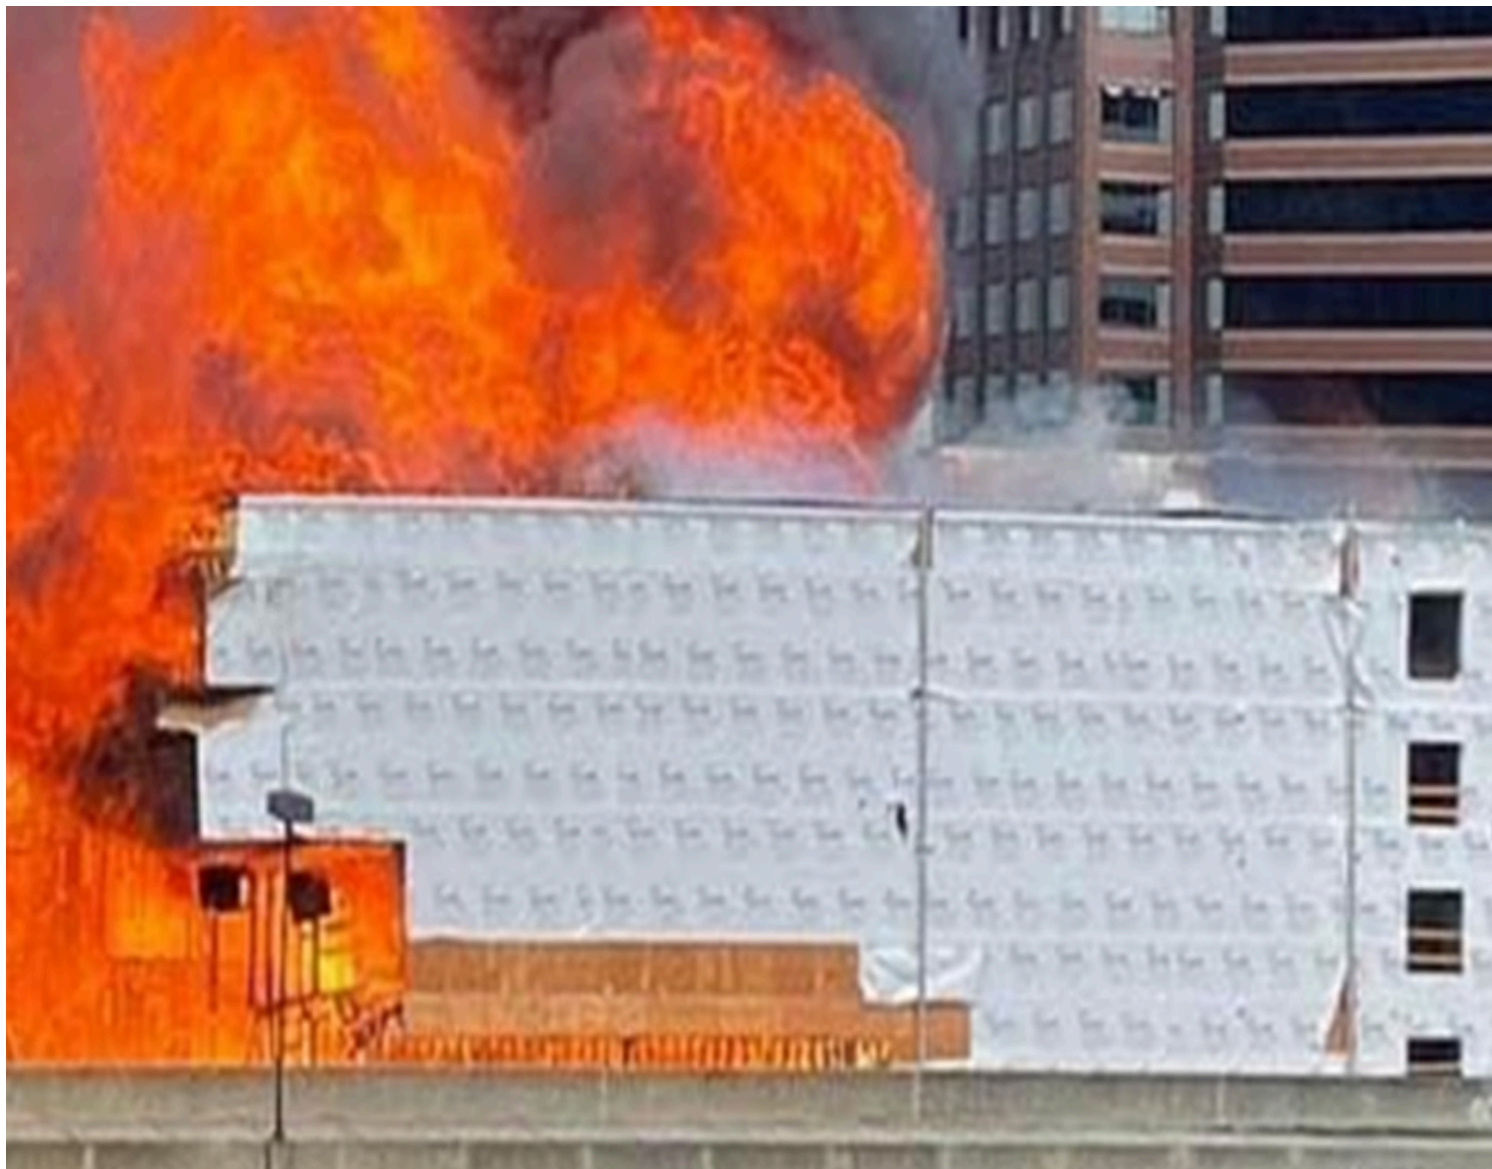
Notice the hole in the exterior sheeting and Tyvek wrapping. This is the hole L01 crew made in an attempt to identify where they were in the building once conditions rapidly deteriorated. This is the “Delta” side.
