# **NATIONAL TRANSPORTATION SAFETY BOARD**

## **AIRCRAFT ACCIDENT REPORT**

**UNCONTROLLED COLLISION WITH TERRAIN  
FLAGSHIP AIRLINES, INC., dba AMERICAN EAGLE  
FLIGHT 3379, BAe JETSTREAM 3201, N918AE  
MORRISVILLE, NORTH CAROLINA  
DECEMBER 13, 1994**

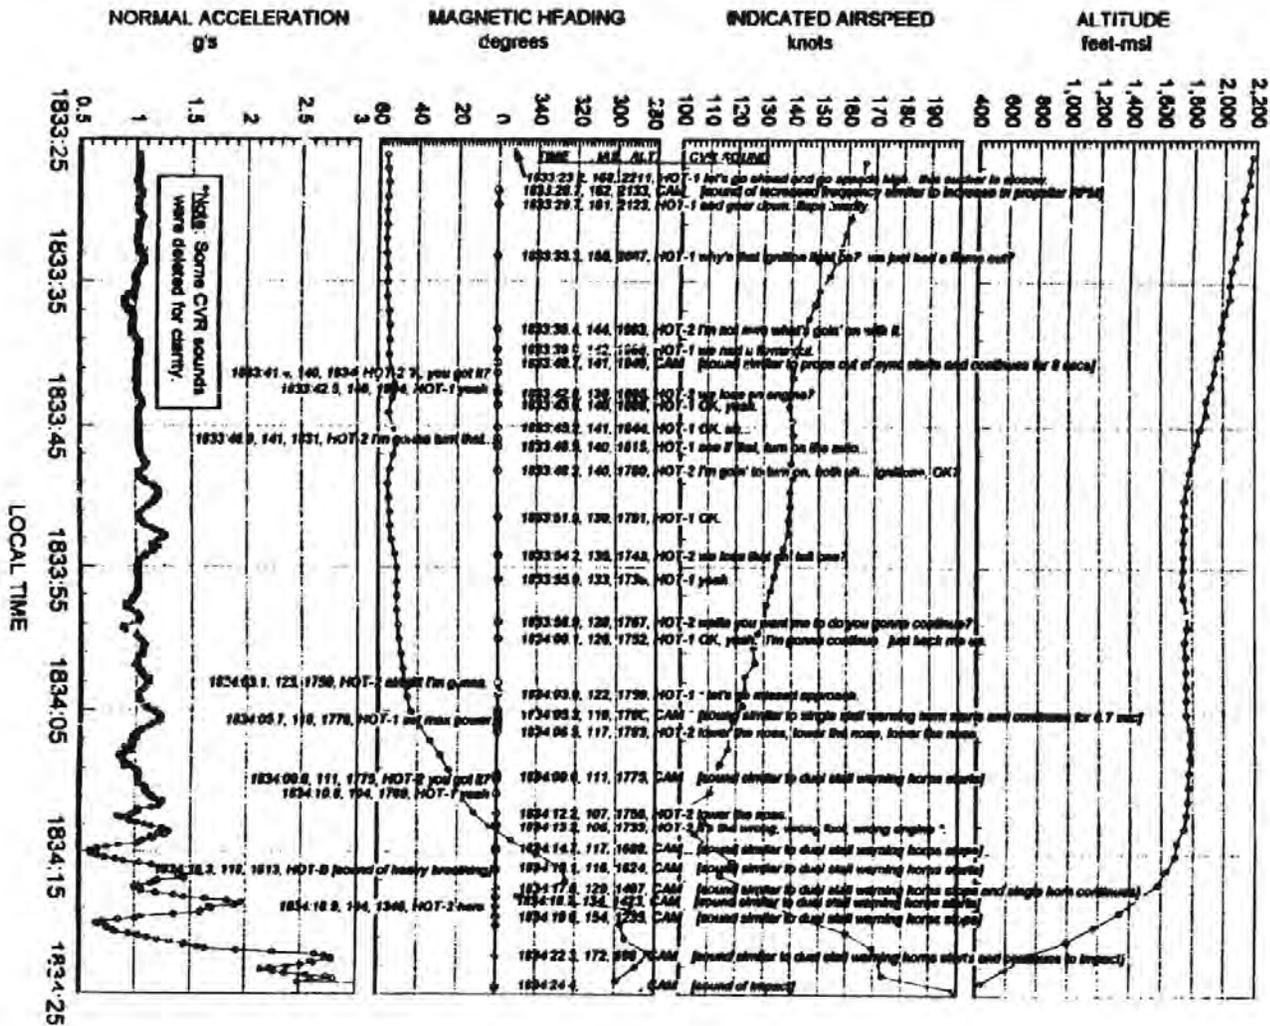
Figure 2.--FDR data.

The aircraft was equipped with a Loral Fairchild Model F800 digital flight data recorder (FDR), Part No. 17M703-274 (S/N 5379).<sup>12</sup> The FDR records pressure altitude, magnetic heading, indicated airspeed, vertical acceleration, and VHF [very high frequency] radio keying data on an elapsed time line for 25 hours before recording over the oldest data. The recorder was heavily damaged by impact forces, and the exterior casing had to be cut away to remove the crash-survivable memory module. This module was slightly damaged on the inside, but the tape was undamaged. The last 3.5 hours of data were transcribed to a disk file for processing. Figure 2 depicts the last minute of FDR/CVR data.
