# HISTORICAL FIRE: 1991 Imperial Foods Processing Plant, Hamlet, N.C.

Fire & Rescue Journal | 8.21.12

*The following article is consists of excerpts from the U.S. Fire Administration/Technical Report Series, USFA-TR-057. The complete report can be viewed [HERE](#).*

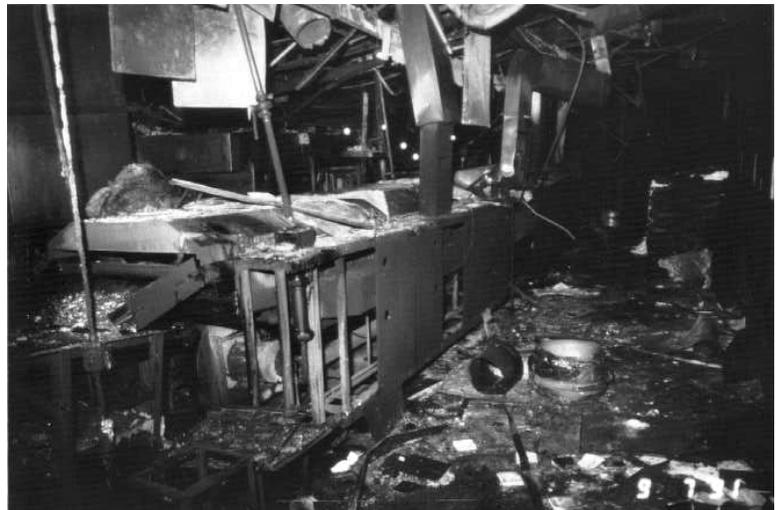
*A view of the cooker vat where the fire started.*

**Origin and Cause:** The conveyor to a cooker had a hydraulic line repaired which burst when brought up to full pressure. Hydraulic fluid expelled at 800 to 1,500 psi, ignited by heating gas plumes from a cooking vat.

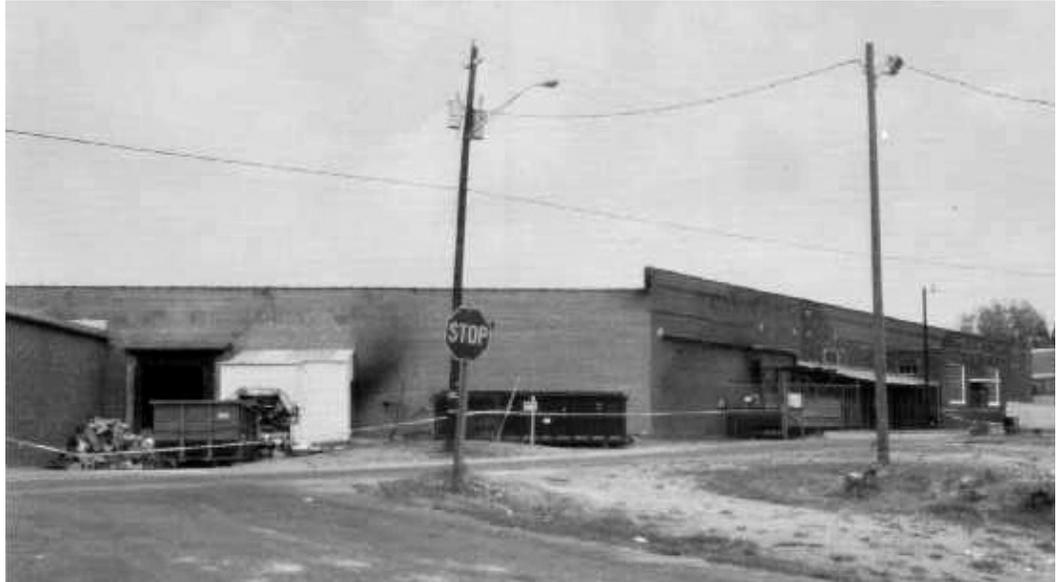
*View of the south end, the southeast corner, and the front of the Imperial Foods building.*
