**NOVEMBER 20, 2021  
NORTH BALD HEAD WYND  
STRUCTURE FIRES  
AFTER ACTION ANALYSIS**

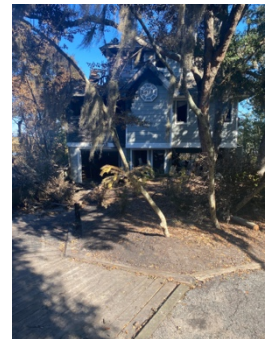
**121 N. Bald Head Wynd Unit 19** is a residential structure with 2,055 heated square footage and 326 unheated square footage totaling 2,381 square feet. Approximate length – 32' x width – 36'. The taxable value is listed at \$474,890.

Fire Flow Requirement: 768 GPM

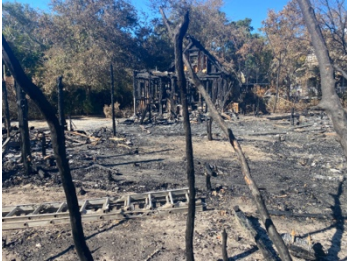
**117 N. Bald Head Wynd** is a residential structure with 2 buildings. The taxable value is listed at \$1,101,650. Building one has 2,256 heated square footage and 1,532 unheated square footage totaling 3,780 square feet. Approximate length – 53' x width – 42'.

Fire Flow Requirement: 1484 GPM
