CHARLOTTE FIRE DEPARTMENT

# LIBERTY ROW FIRE AFTER ACTION REPORT

INCIDENT # 23-0147427

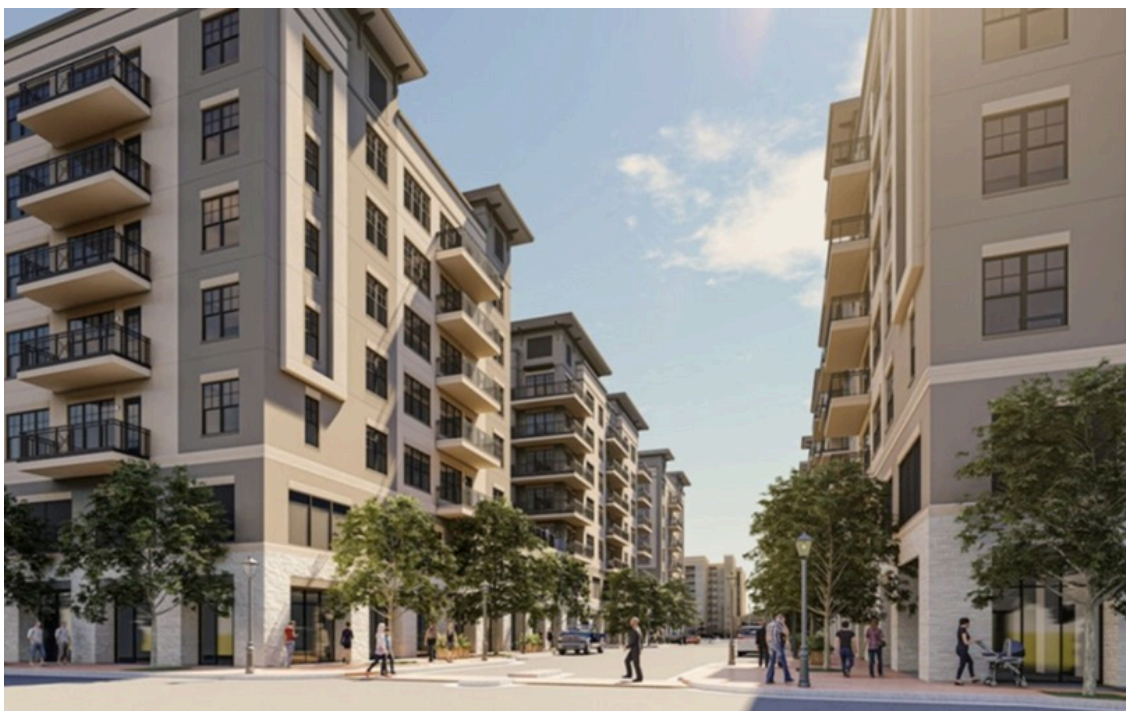
PHOTO # 3

The building was under construction and designed to be a 7-story 239-unit luxury apartment building (photo 3, 4, 5) of podium construction, consisting of a 5-story wood frame apartment over 2-story concrete parking garage. An overview would show the building was to be in the shape of a W. The building was approximately 355' long and 120' deep. It was framed, but with no compartmentalization. Therefore, no sheetrock or other barrier existed to prevent unimpeded fire growth. An exact duplicate building, in nearly the exact stage of construction, was located across Liberty Row Drive approximately 60' away.

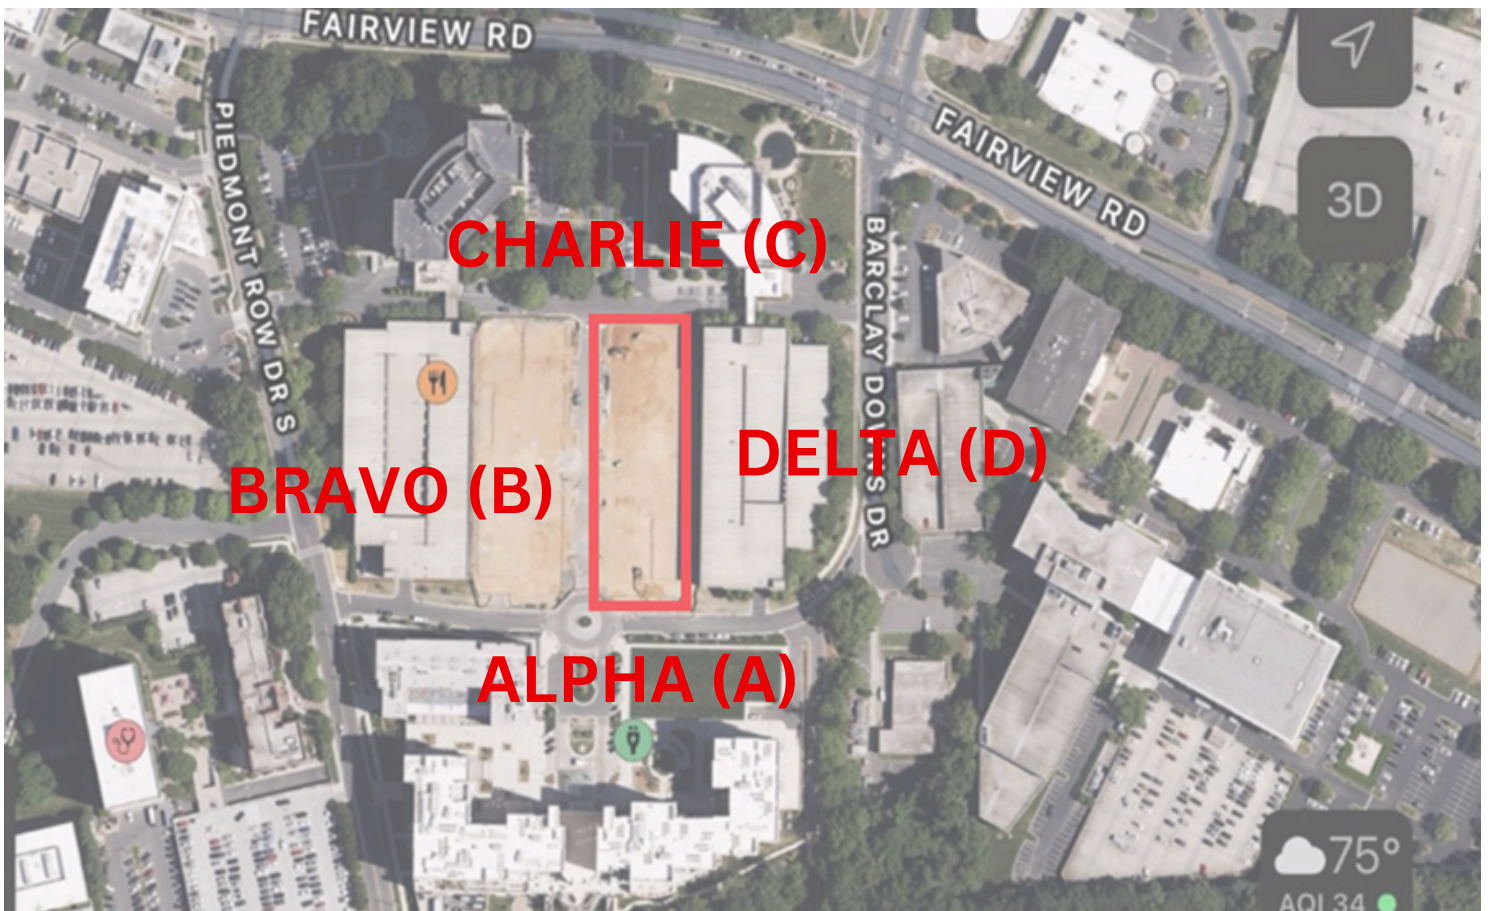
- “Alpha” side – this is Barclay Downs Dr. as well but it is where the round-about is
- “Bravo” side – Liberty Row Dr. (between the buildings/parking decks)
- “Charlie” side – Fairview Rd.
- “Delta” side – Barclay Downs Dr
