REPORT

WILMINGTON,
NORTH CAROLINA

NATIONAL BOARD OF FIRE UNDERWRITERS

FIRE PREVENTION AND ENGINEERING STANDARDS

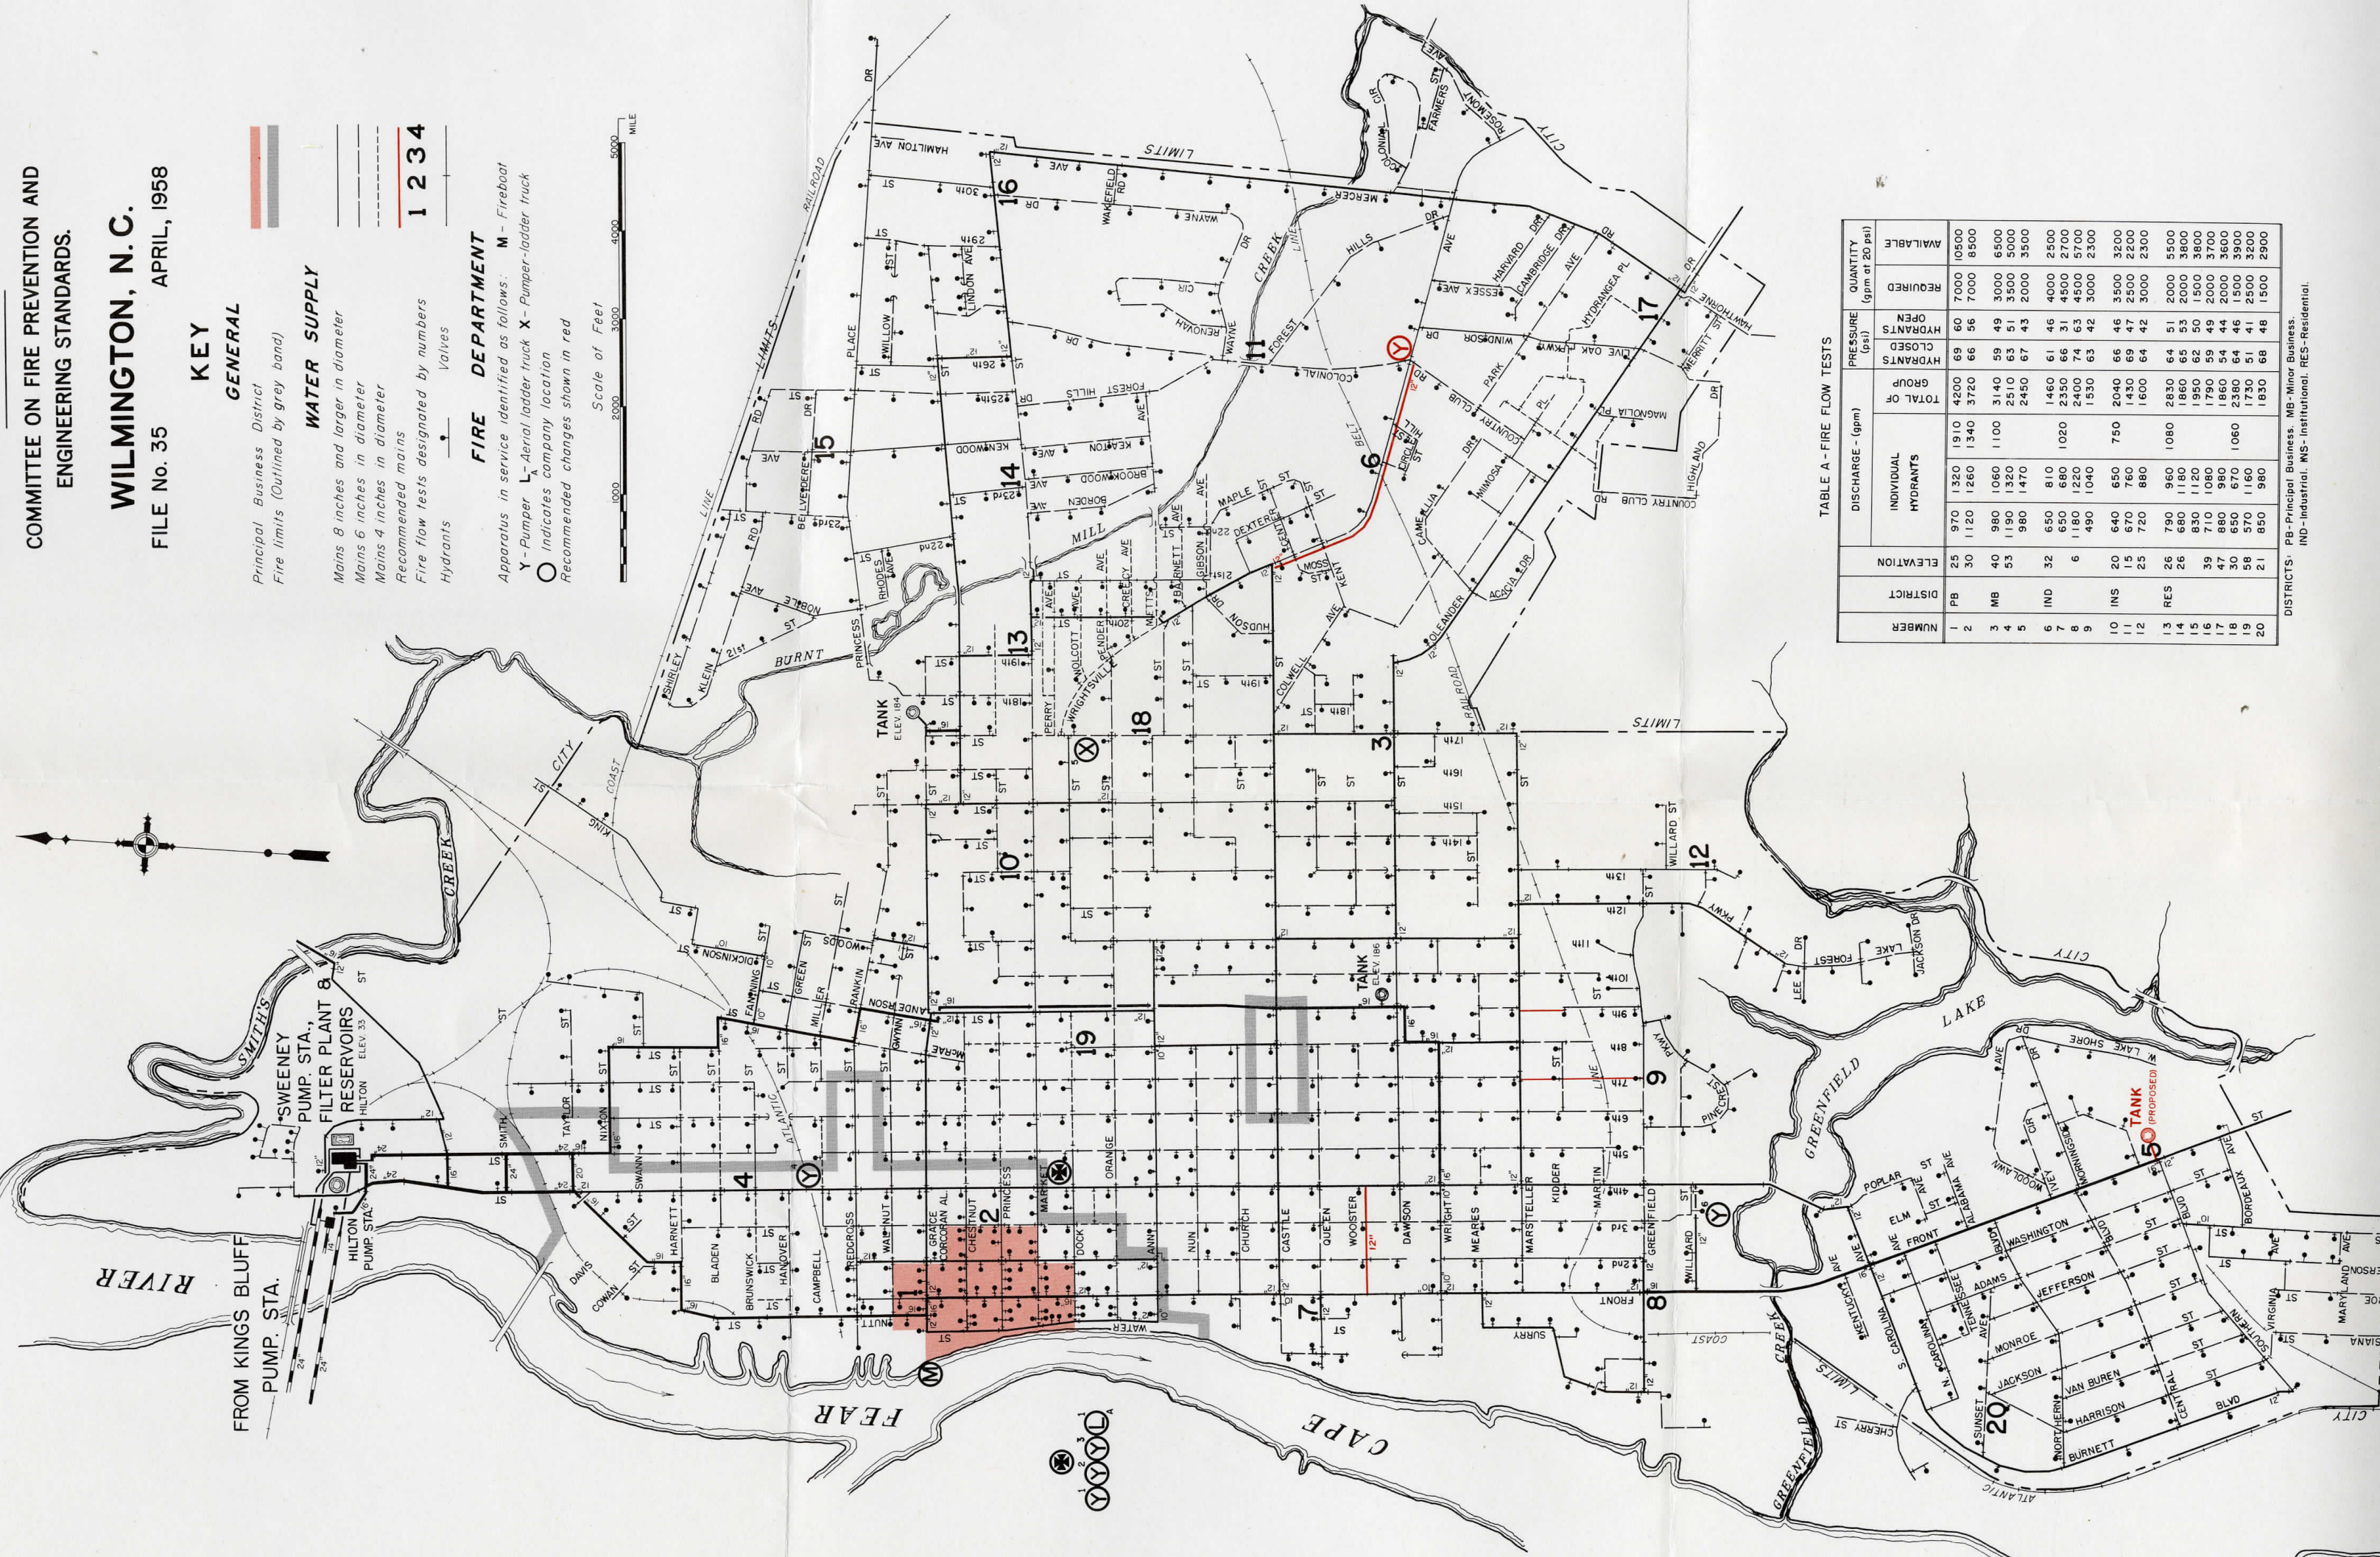
Mains 8 inches and larger in diameter
Mains 6 inches in diameter
Mains 4 inches in diameter
Recommended mains
Fire flow tests designated by numbers
Hydrants
Valves

Apparatus in service identified as follows: M - Fireboat
Y - Pumper L - Aerial ladder truck X - Pumper-ladder truck
O - Indicates company location
Recommended changes shown in red
