Looking Back:

# Wilmington Terminal and Warehouse Company

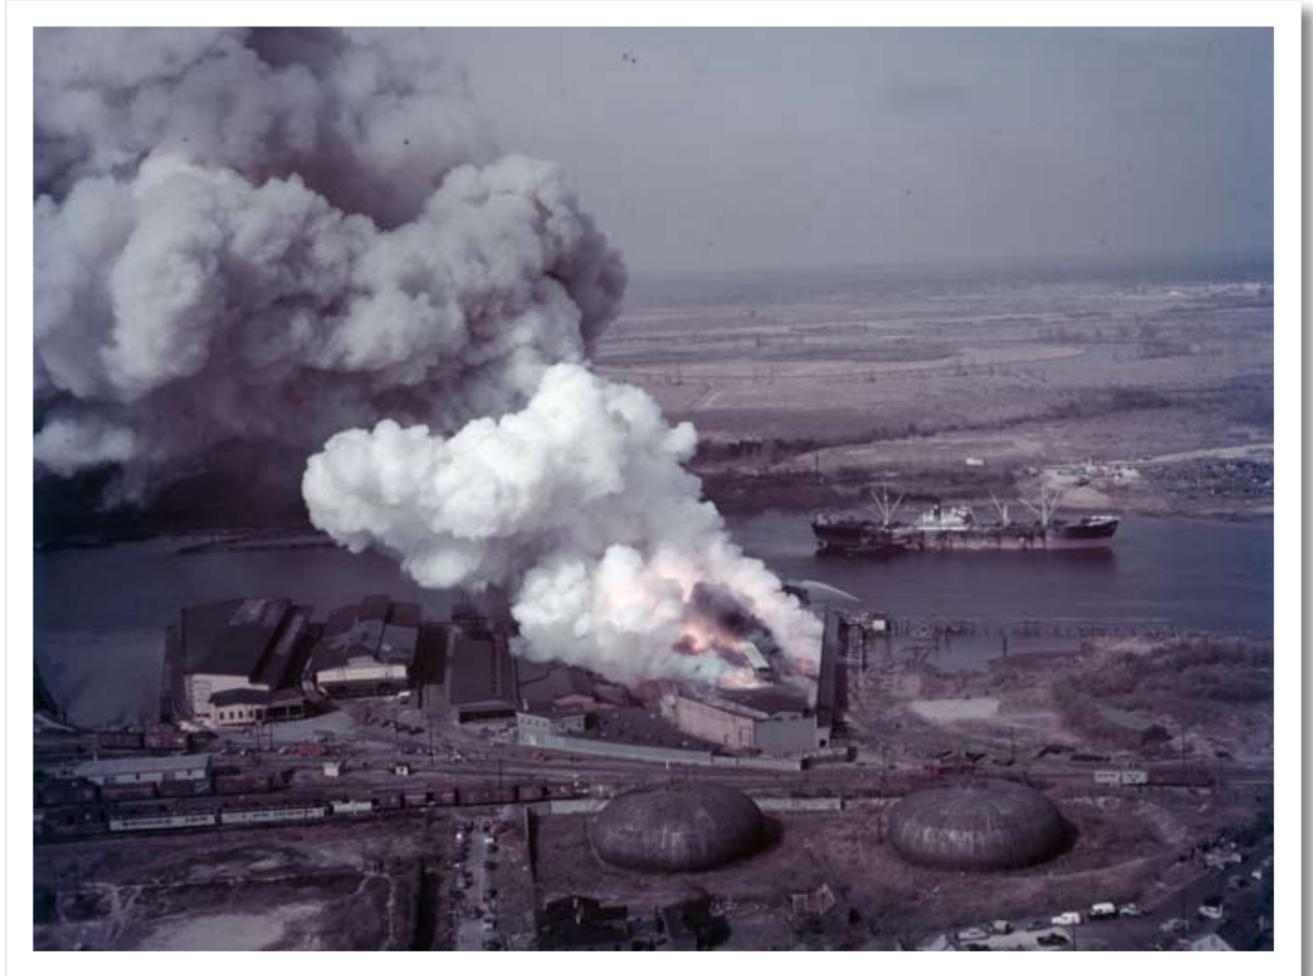
*A view of the fire in it's early stages from the east. Note the Max Manus in the river away from the wharf.*

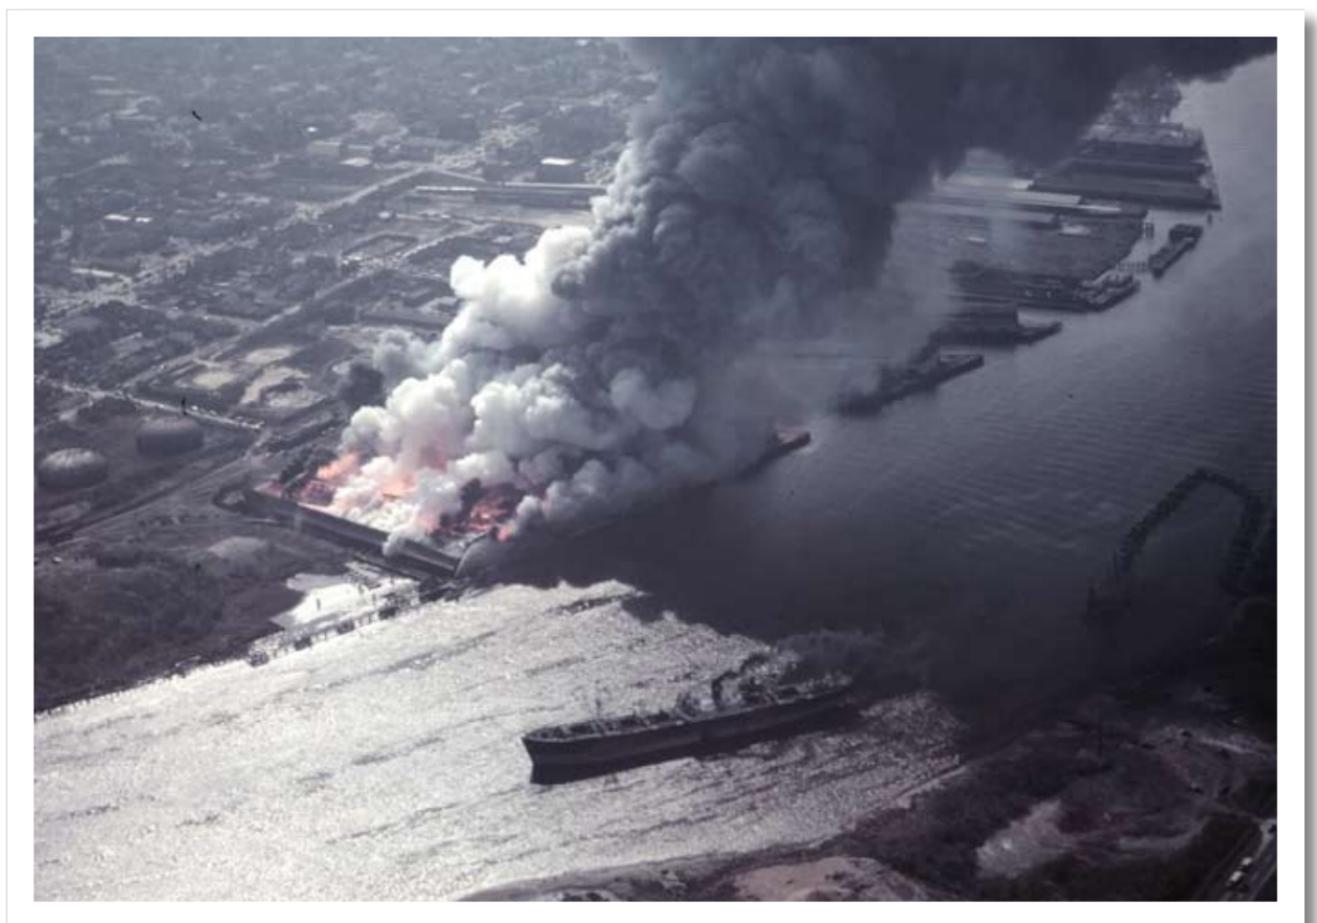
*Western view of the fire, which had been burning approximately 30-45 minutes. All of the warehouses to the left would eventually be fully involved.*
